ANNUAL REPORT FOR 2000

Pembroke Creek Mitigation Site
Chowan County
Project No. 8.T010602
TIP No. R-2512

Prepared By:
Natural Systems Unit & Roadside Environmental Unit
North Carolina Department of Transportation
December 2000

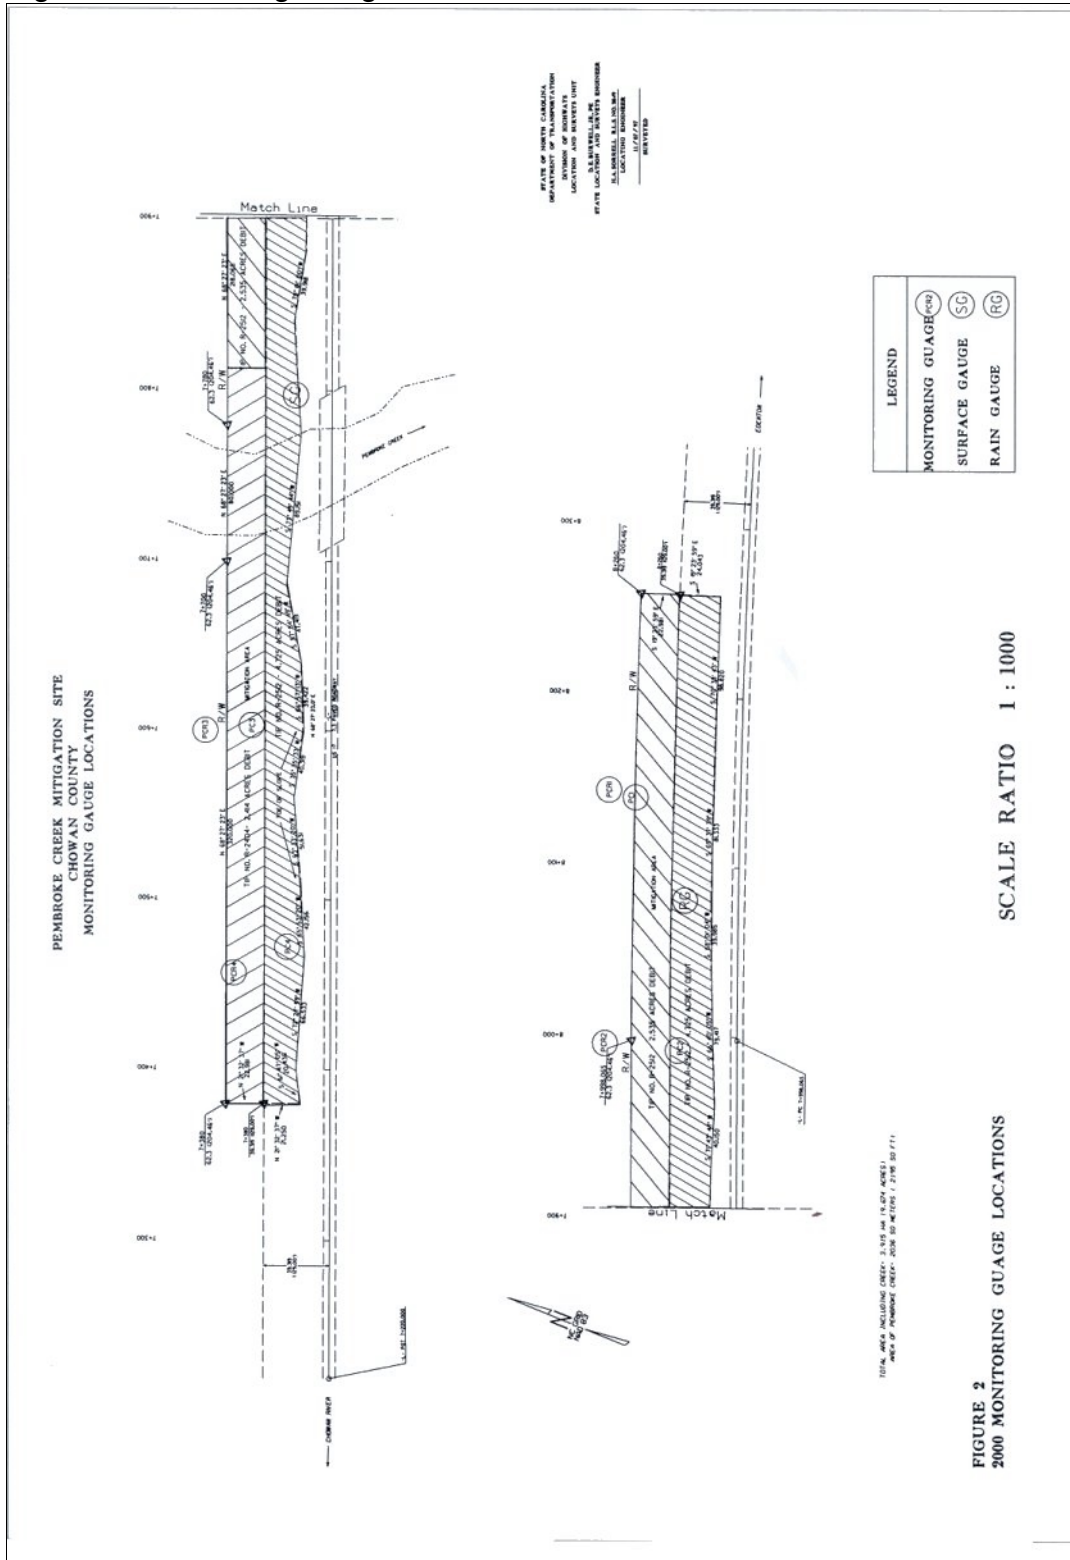
Figure 2. Monitoring Gauge Locations

Eight monitoring gauges, one rain gauge, and one surface water gauge were installed on site in February 1999 and data was recorded starting in March 1999 (Figure 2). The automatic monitoring gauges and rain gauges record the depth to groundwater and rainfall, respectively. Data was collected on a daily basis throughout the growing season.

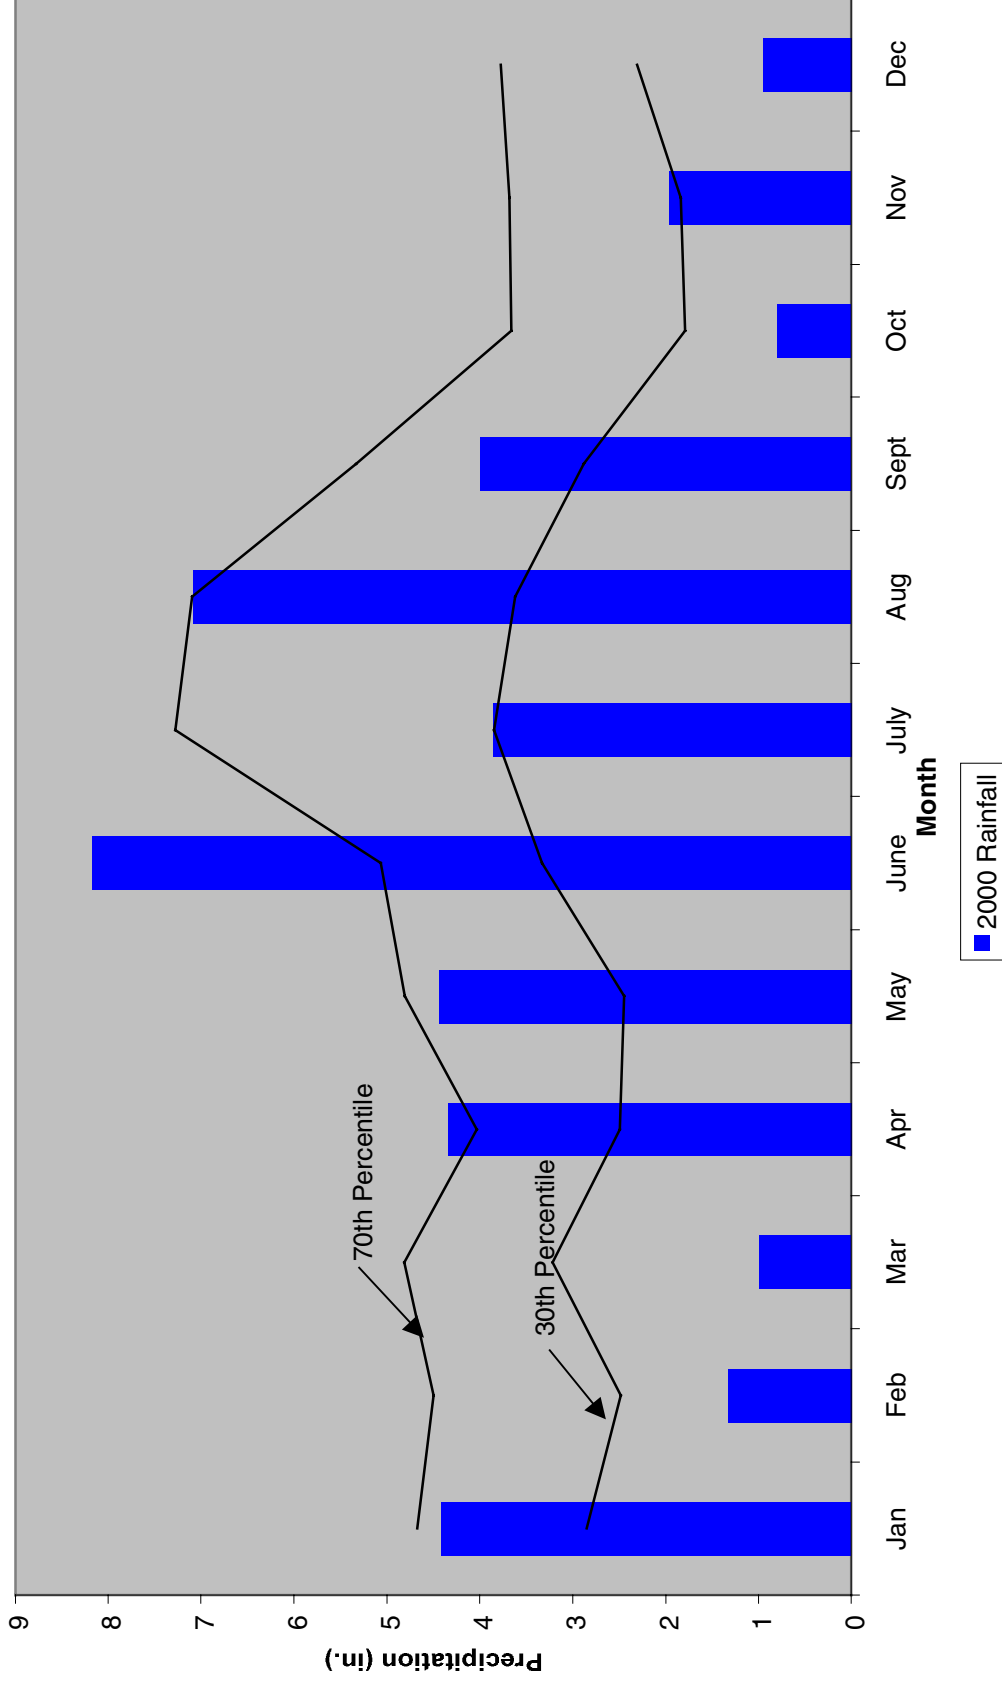
Pembroke Creek 30-70 Percentile Graph
Edenton, NC

Figure 4 is a comparison of 2000 monthly rainfall to historical precipitation for the Edenton area. Rainfall data recorded at the Edenton weather station and onsite during the growing season was compared to the historical 30-70 percentile trends for the area. It is assumed that if the 2000 rainfall totals, represented by bars, fall between the average precipitation values for each month, then the local climate was experiencing average conditions for that particular region.

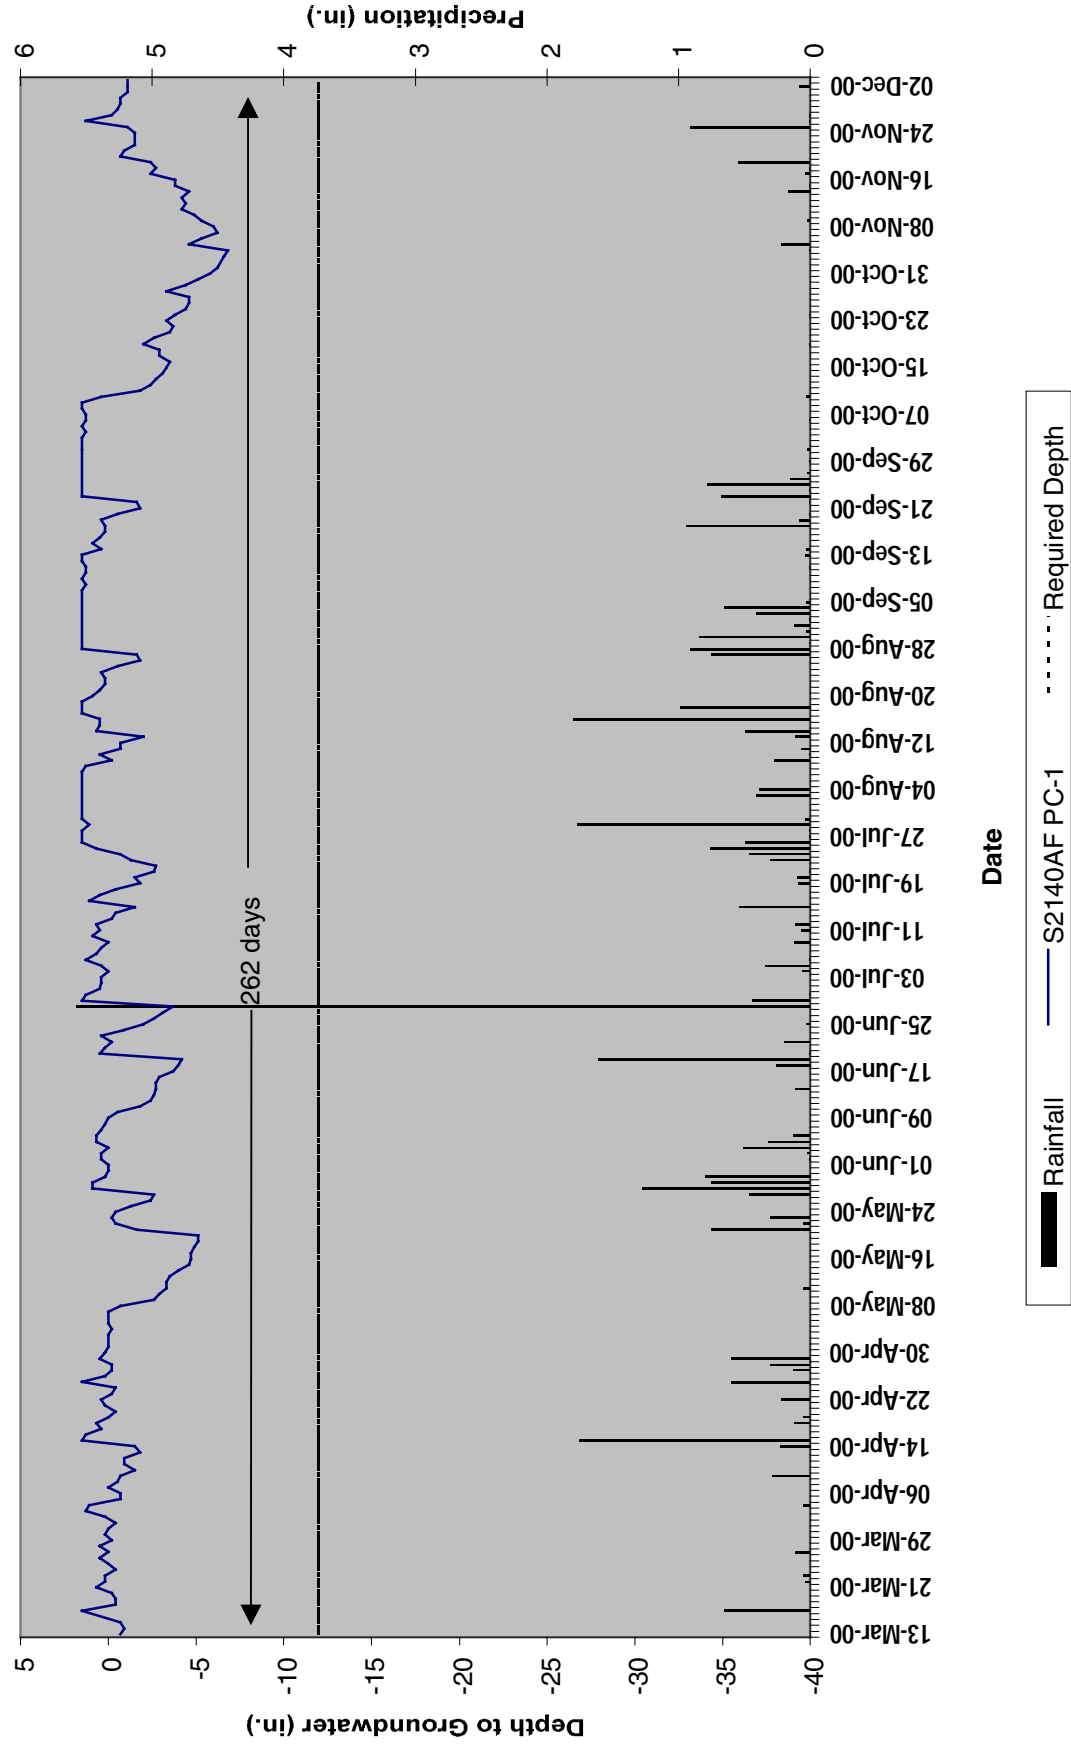
Pembroke Creek PC-1

Appendix A contains a plot of the water depth for each monitoring gauge and surface water gauge in 2000. Precipitation events are included on each graph as bars.

| Monitoring Gauge | < 5% | 5% - 8% | 8% - 12.5% | > 12.5% | Actual % | Dates of Success |
|---|---|---|---|---|---|---|
| PC-1 | | | | ✓ | 100% | Mar 13- Dec 1 |

Specific monitoring gauge problems: PCRG-1 stopped recording on 2/19/00, battery was replaced and set to record on 3/21/00. PC-1 stopped recording on 9/14/00, battery was replaced and set to record on 10/11/00. Figure 3 is a graphical representation of the hydrologic monitoring results.

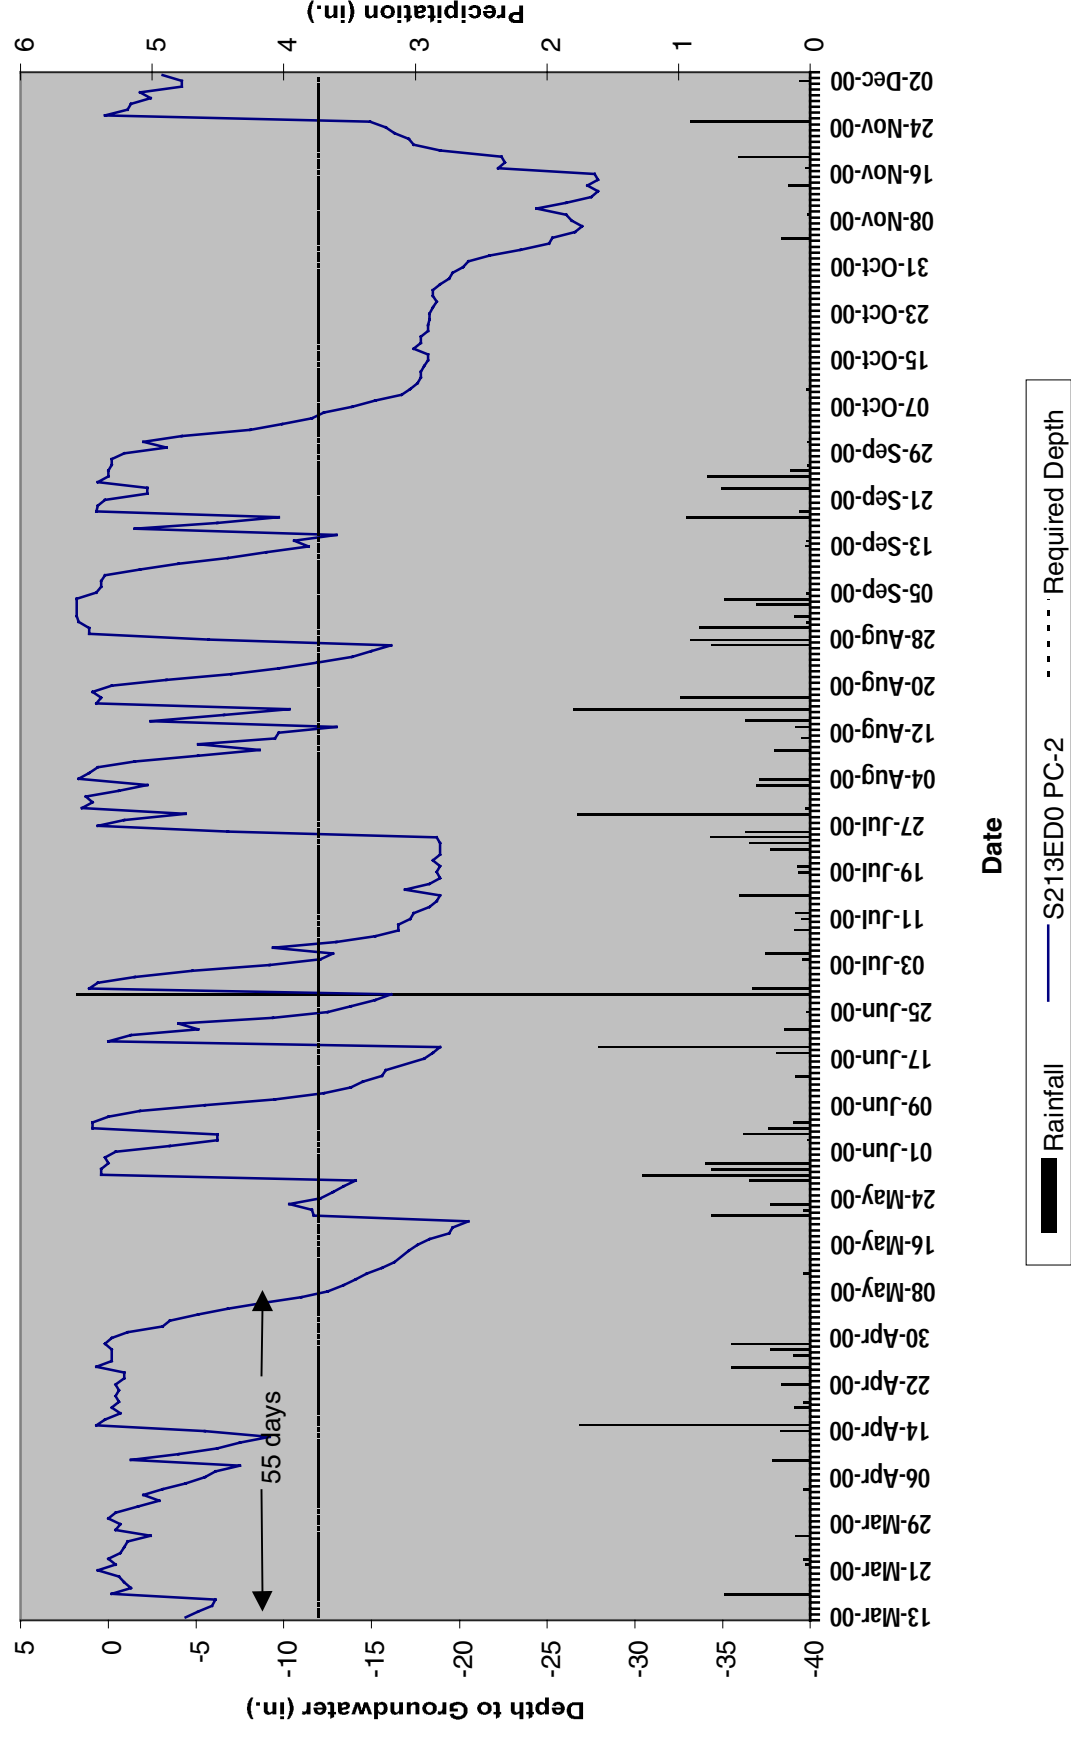
Pembroke Creek PC-2

| Monitoring Gauge | < 5% | 5% - 8% | 8% - 12.5% | > 12.5% | Actual % | Dates of Success |
|---|---|---|---|---|---|---|
| PC-2 | | | | ✓ | 21% | Mar 13- May 7 |

Hydrologic success for this site is based on the mean depth to groundwater of the gauges in the restoration area being less to not greater to 20% of the mean depth to groundwater of the gauges in the respective reference area. One gauge, PC-2 did not fall within 20% of the mean depth to watertable of its reference gauge (PCR-2). The water table, however, was within 12 inches of surface for more than 12.5% of the growing season, which meets the standard hydrologic criteria. Therefore, monitoring from the 2000 growing season indicates success in both hydrology and vegetation survival.

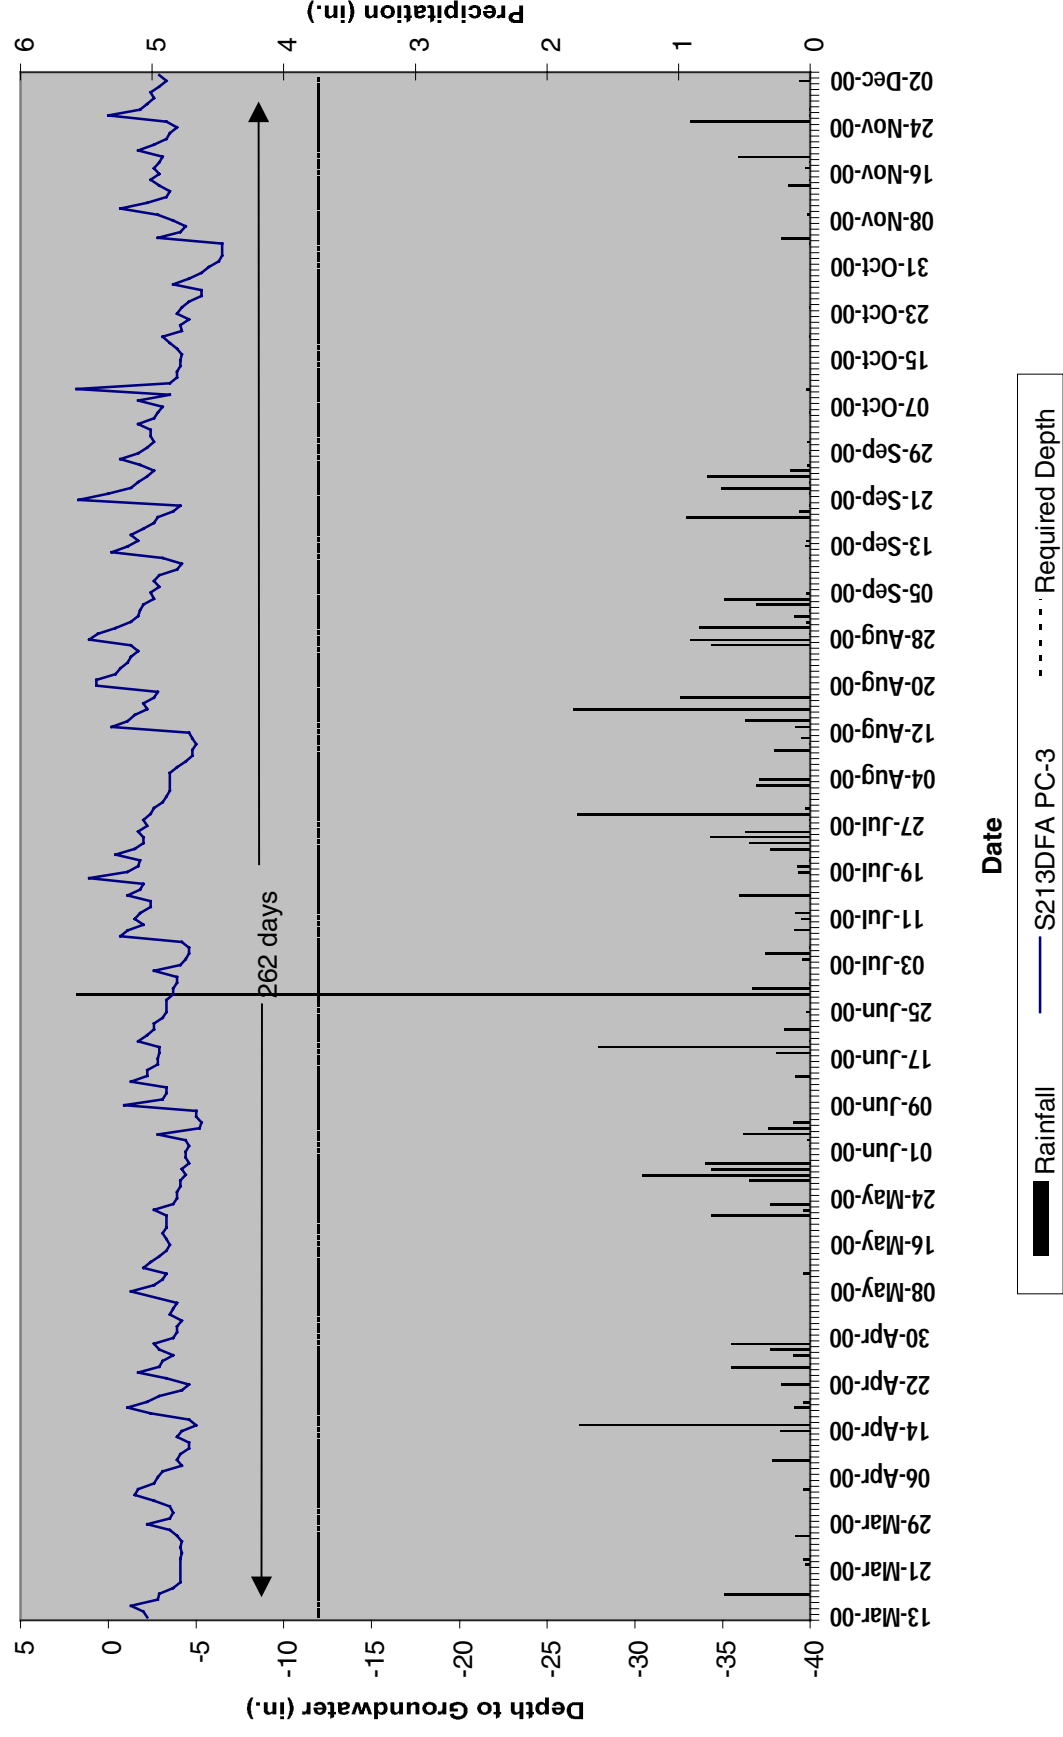
Pembroke Creek PC-3

| Monitoring Gauge | < 5% | 5% - 8% | 8% - 12.5% | > 12.5% | Actual % | Dates of Success |
|---|---|---|---|---|---|---|
| PC-3 | | | | ✓ | 100% | Mar 13- Dec 1 |

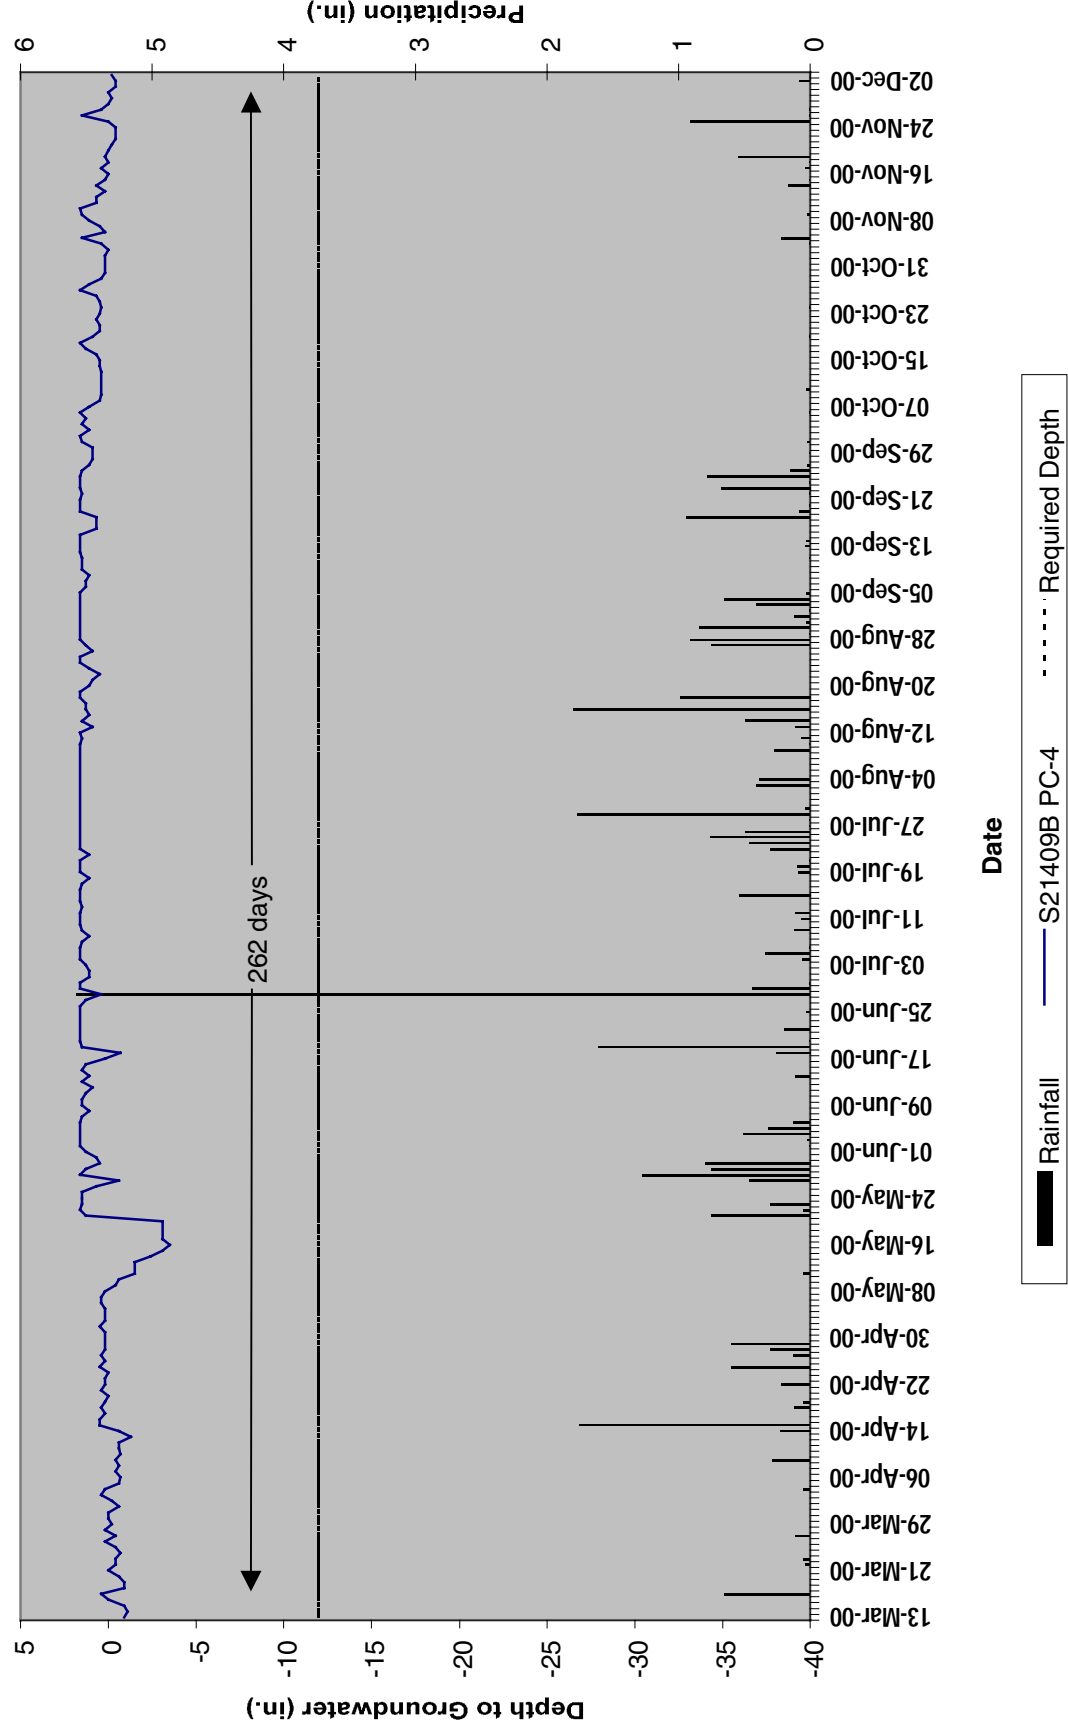
Pembroke Creek PC-4

| Monitoring Gauge | < 5% | 5% - 8% | 8% - 12.5% | > 12.5% | Actual % | Dates of Success |
|---|---|---|---|---|---|---|
| PC-4 | | | | ✓ | 100% | Mar 13- Dec 1 |

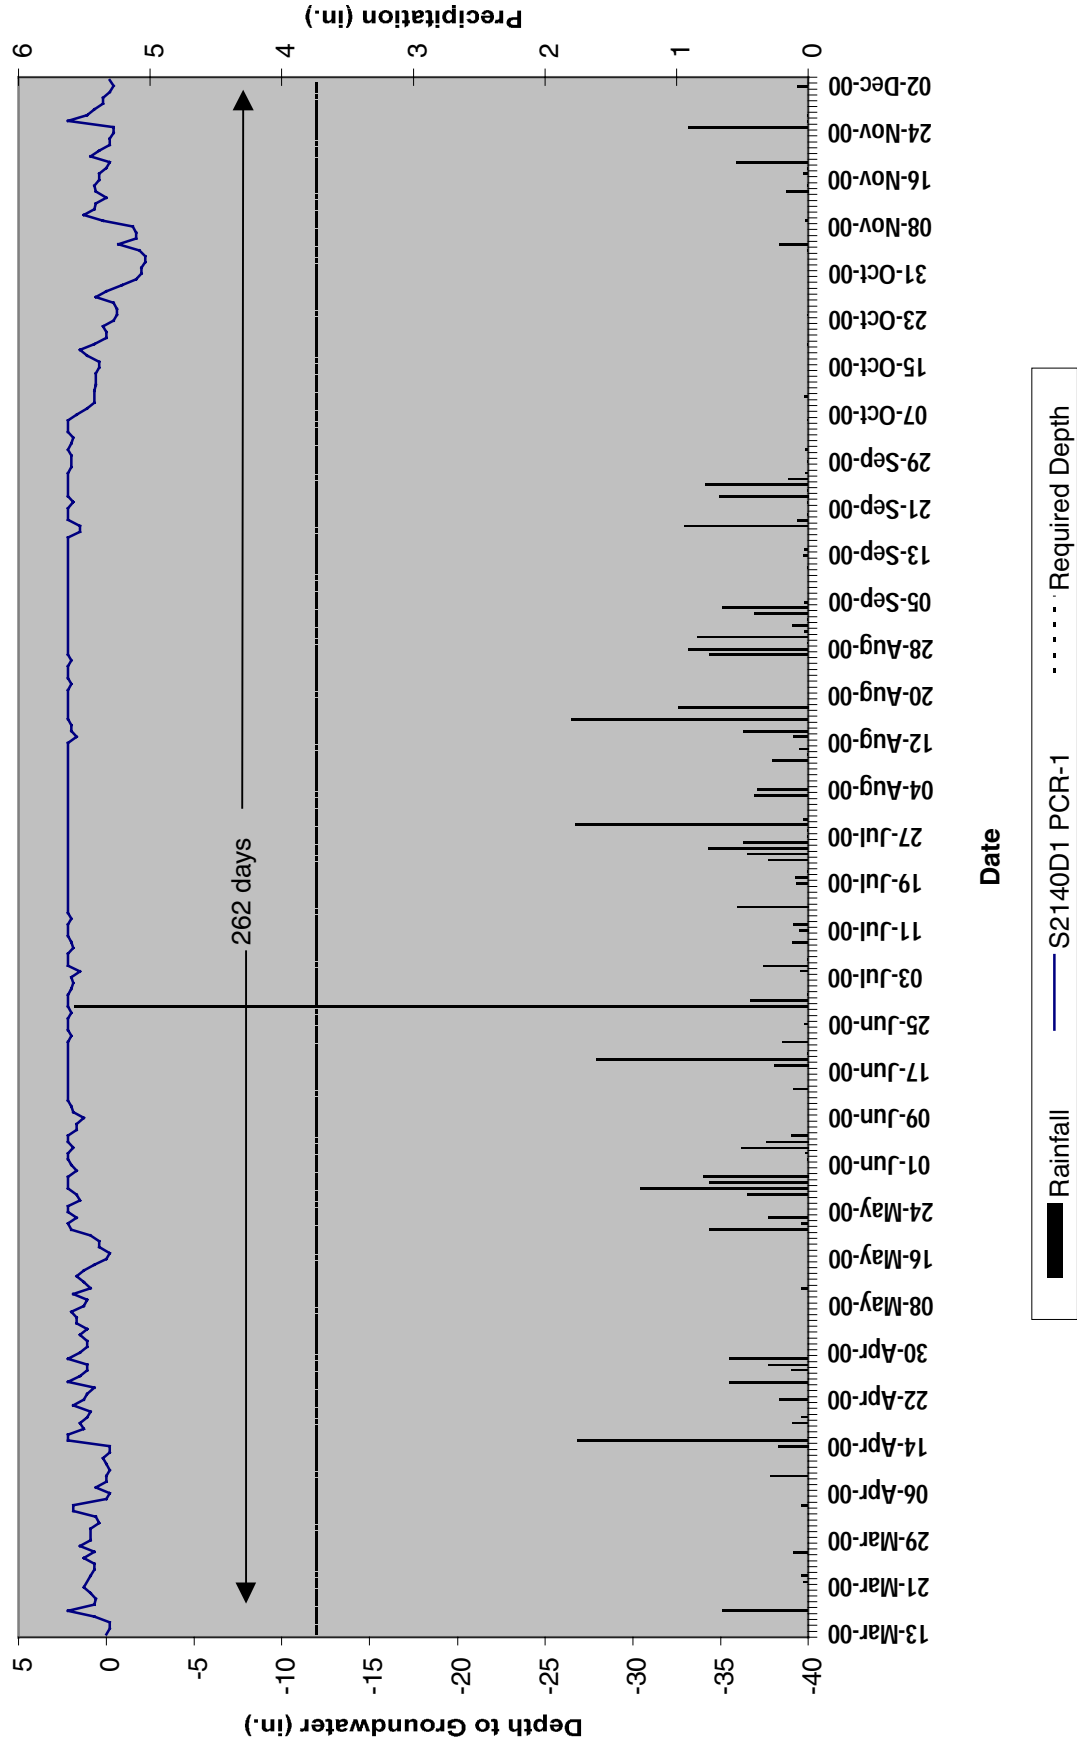
Pembroke Creek PCR-1

| Monitoring Gauge | < 5% | 5% - 8% | 8% - 12.5% | > 12.5% | Actual % | Dates of Success |
|---|---|---|---|---|---|---|
| PCR-1 | | | | ✓ | 100% | Mar 13- Dec 1 |

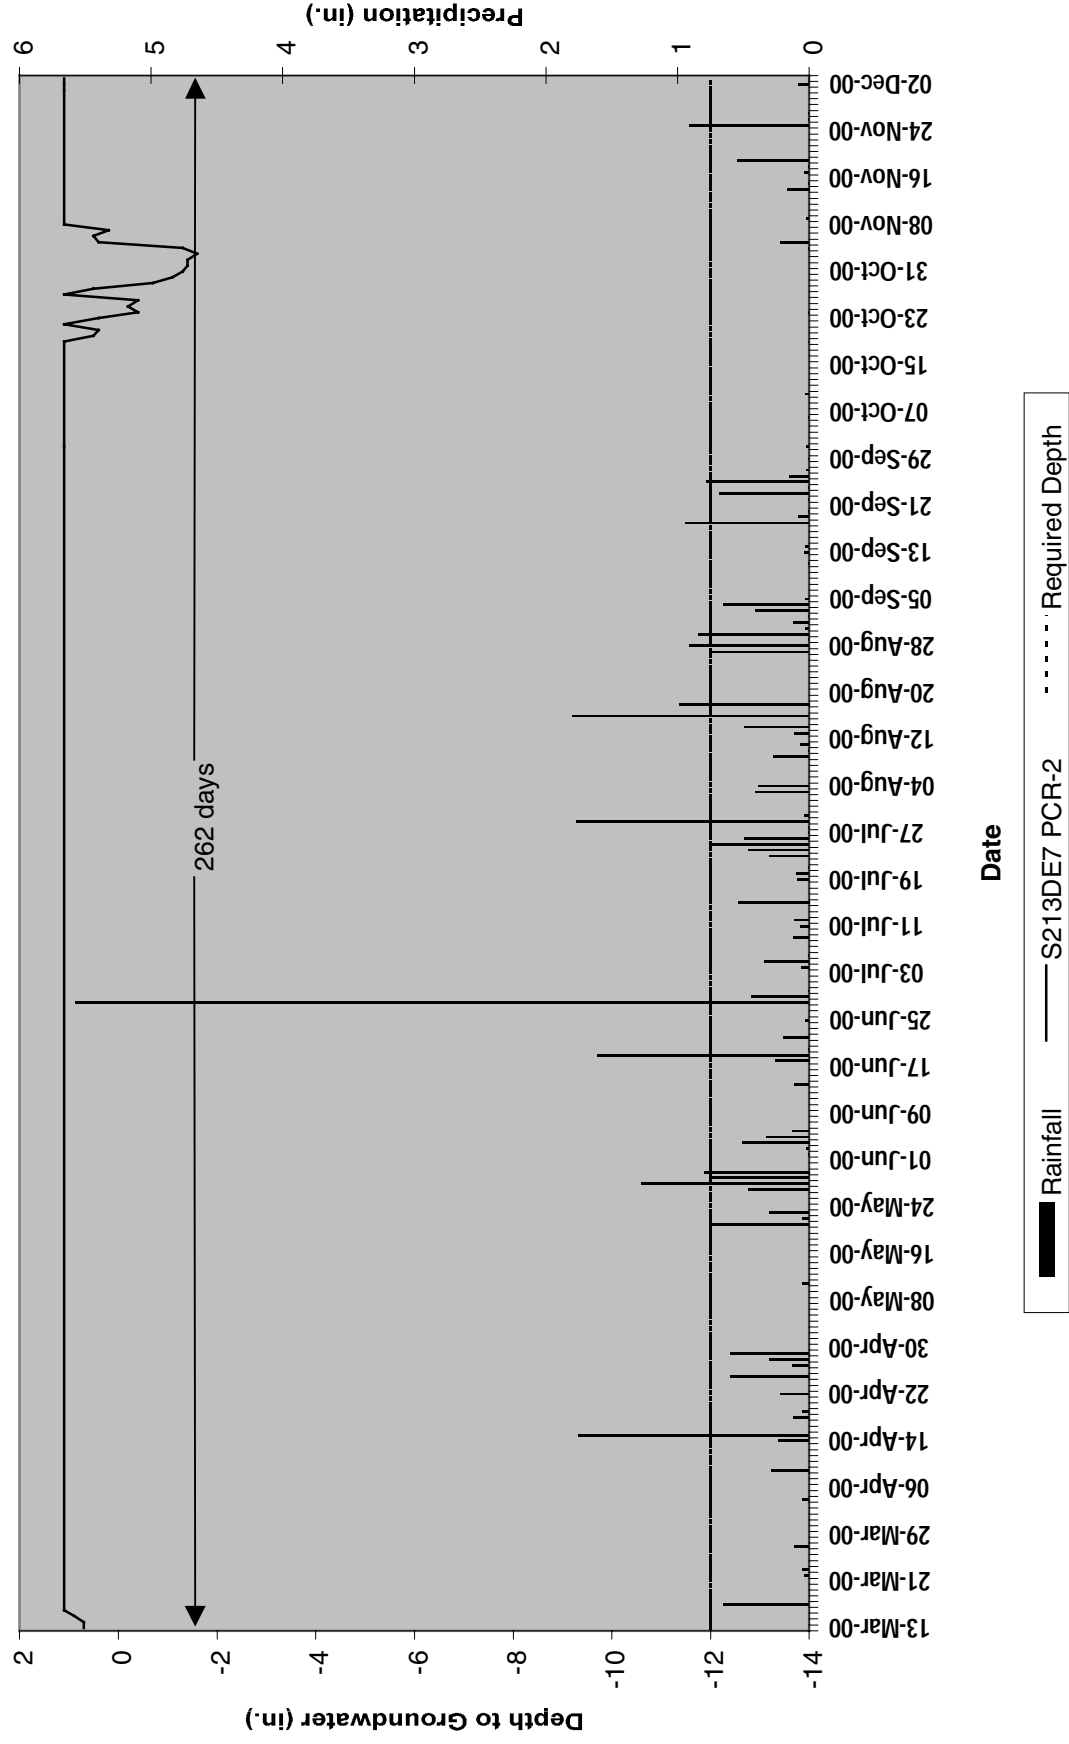
Pembroke Creek PCR-2

| Monitoring Gauge | < 5% | 5% - 8% | 8% - 12.5% | > 12.5% | Actual % | Dates of Success |
|---|---|---|---|---|---|---|
| PCR-2 | | | | ✓ | 100% | Mar 13- Dec 1 |

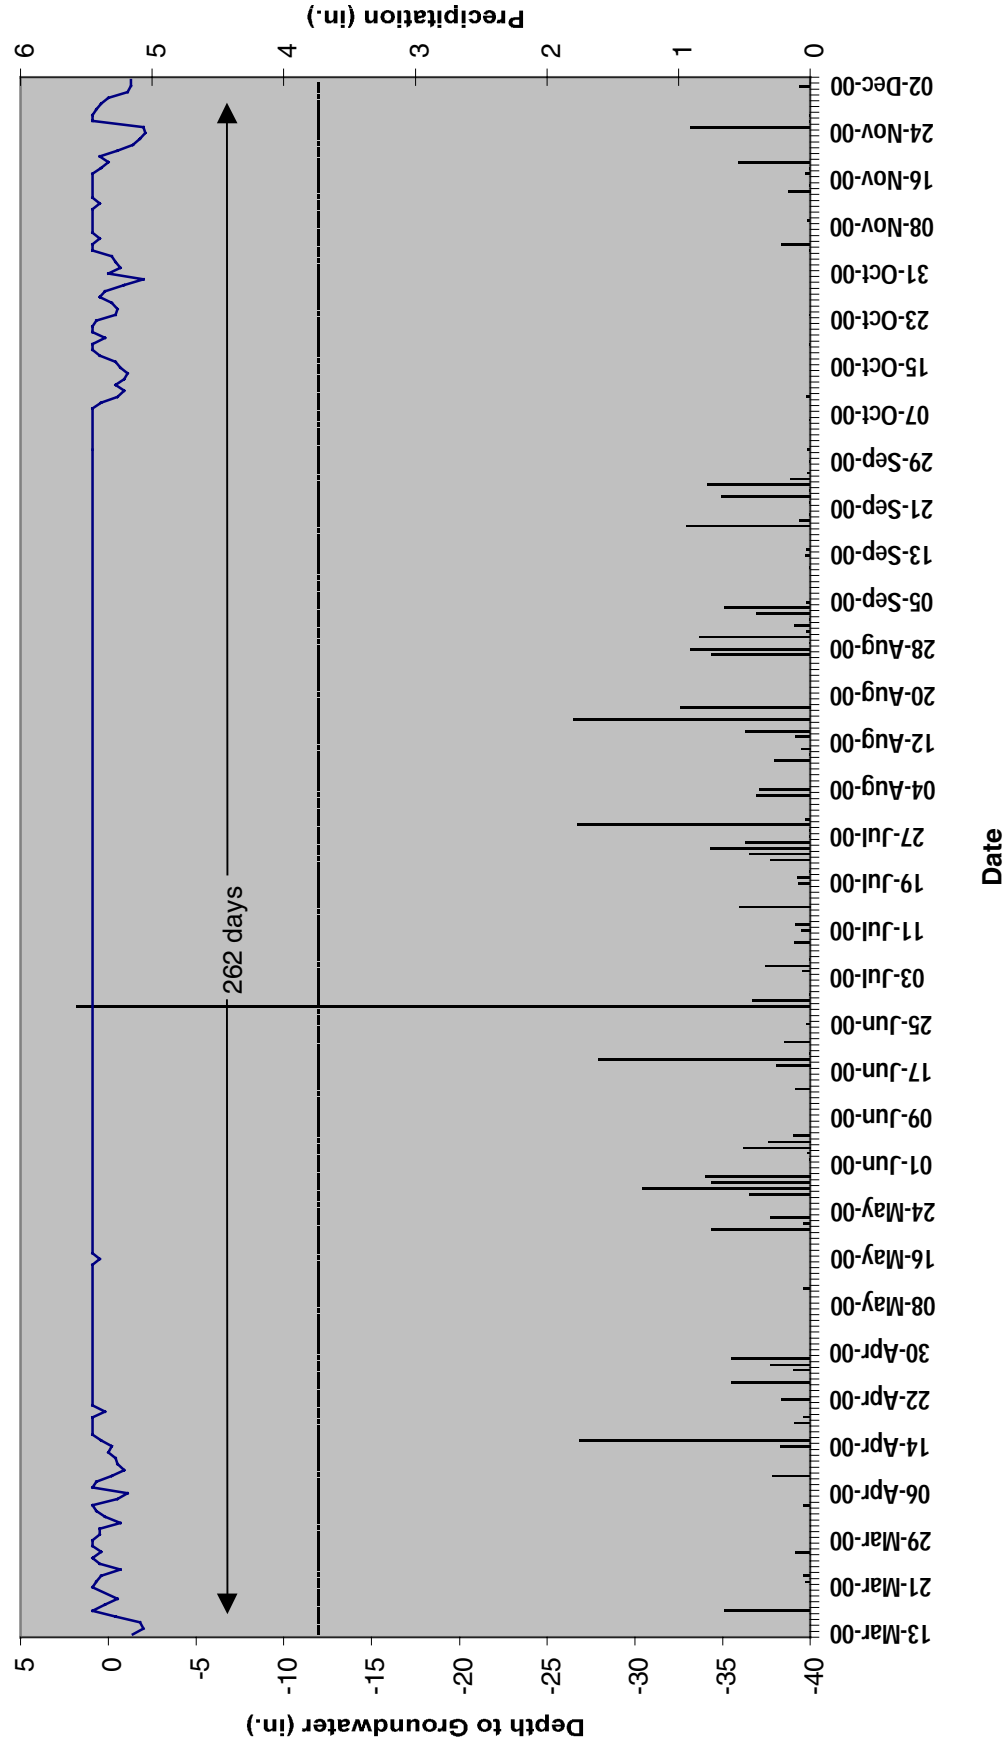
Pembroke Creek PCR-3

| Monitoring Gauge | < 5% | 5% - 8% | 8% - 12.5% | > 12.5% | Actual % | Dates of Success |
|---|---|---|---|---|---|---|
| PCR-3 | | | | ✓ | 100% | Mar 13- Dec 1 |

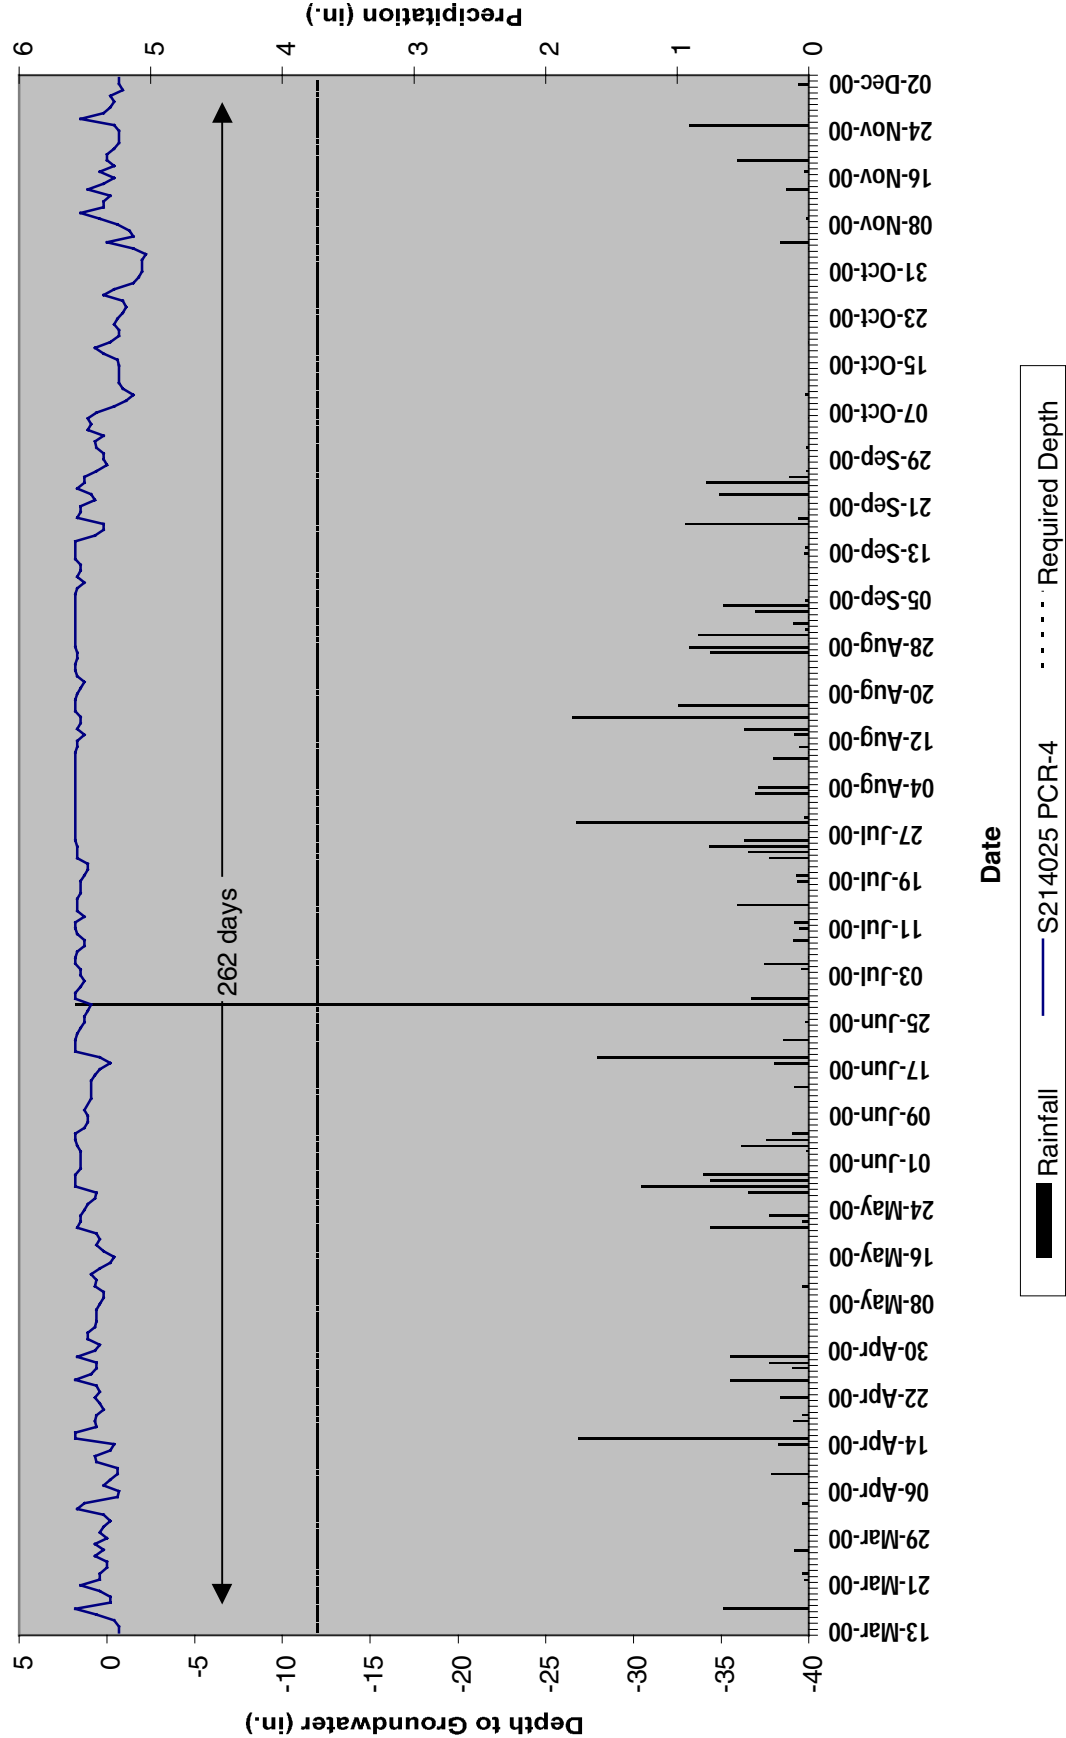
Pembroke Creek PCR-4

| Monitoring Gauge | < 5% | 5% - 8% | 8% - 12.5% | > 12.5% | Actual % | Dates of Success |
|---|---|---|---|---|---|---|
| PCR-4 | | | | ✓ | 100% | Mar 13- Dec 1 |

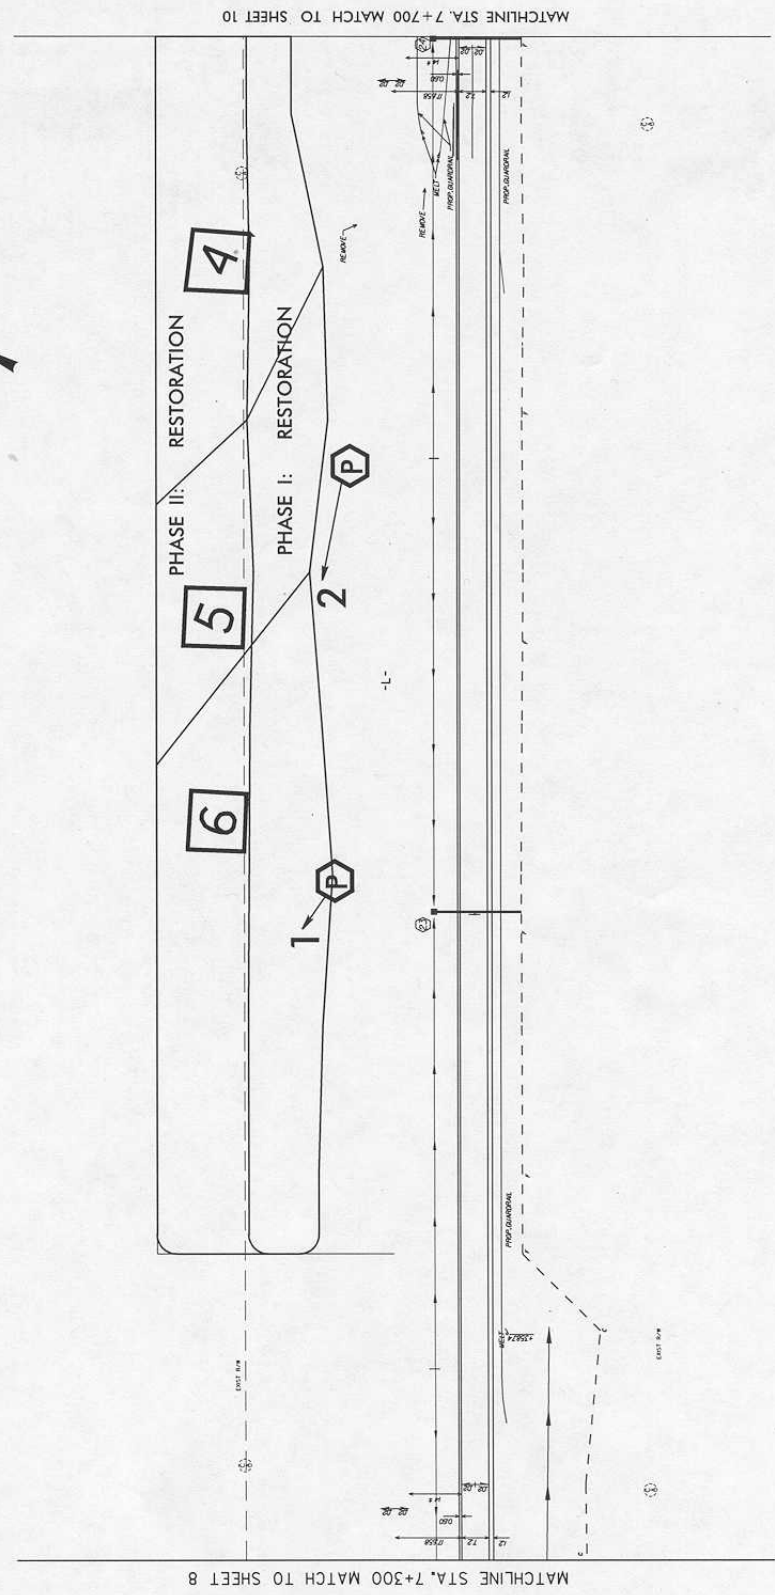
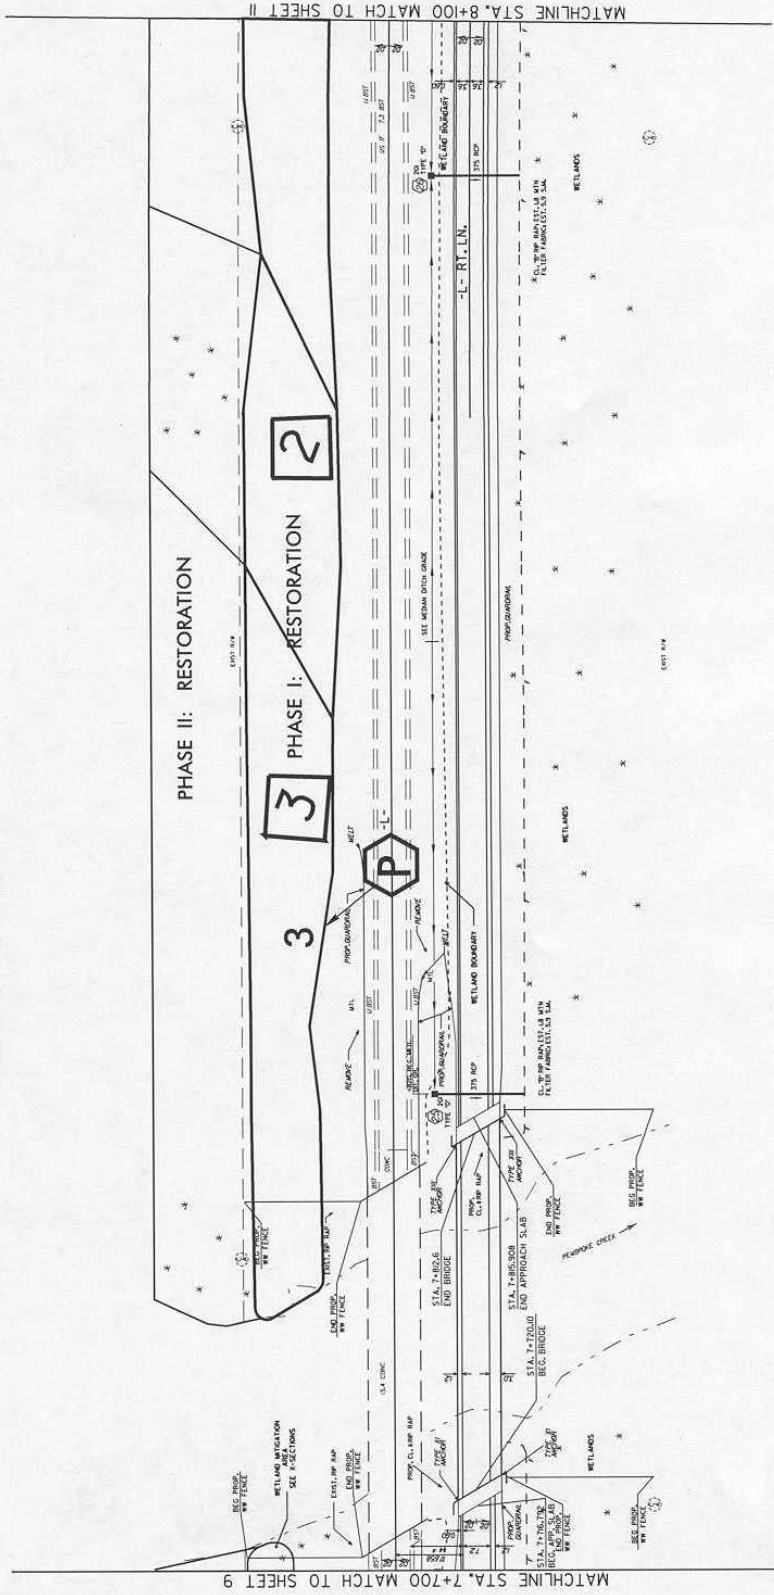
PEMBROKE CREEK
Wetland Mitigation Site
Photo and Plot Locations

To determine tree density, 50' x 50' plots were installed immediately following planting. The actual number of planted trees which occur within the plot was counted. This number was equated to the number within each plot, which represents 680 trees per acre (average). The survival monitoring number was compared to the planted number to obtain survival percentage. This percentage was applied to the 680 trees per acre to obtain an estimated tree per acre for the site. (Density = monitoring count / planted trees x 680)
